Inspecting Exhaust Manifolds and Risers

By Charles Fort

Manifolds and risers are some of the less-discussed "consumables" on your boat. But when they corrode internally, they often destroy the engine.

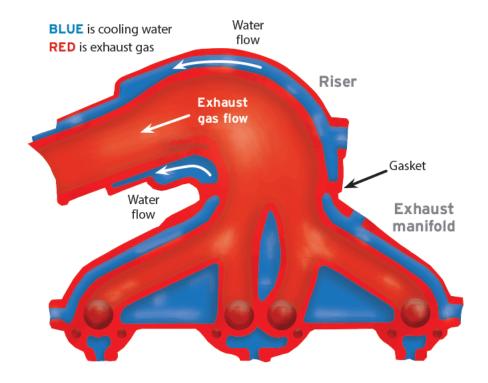
Illustration: Marcus Floro

Exhaust manifolds and risers are large metal castings that carry hot exhaust gases away from the engine on inboard engines. All V-8 and V-6 engines, for instance, have a separate exhaust manifold along the side of each cylinder bank. The riser, which is often shaped like an inverted U, is located at the aft end or centered on top of the manifold. Sometimes the riser slopes down from the end of the manifold, if the engine sits high enough above the waterline, in which case it's often called an elbow. The exhaust hose is then attached to the aft end of the riser or elbow.

What makes these cast-iron parts unique is that they're pipes within another pipe. This double-wall arrangement allows hot exhaust gases in the internal pipe to be surrounded by water in the external pipe, called a water jacket, which should remain cool enough to touch. At the aft end of the riser, water from the water jacket combines with and cools the hot exhaust gases before continuing out the exhaust overboard discharge. Without the cooling effect of the water, the exhaust gas would overheat the manifold and risers, then burn through the exhaust hose in short order.

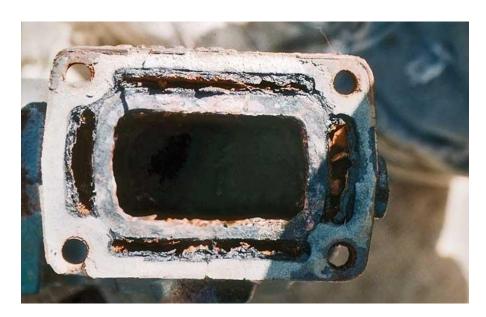
Corrosion between the water and gas passages may let water into the engine, which can destroy it. (Photo: BoatUS Insurance Files)

Keeping the water and exhaust gases separated until they exit the riser is crucial. If water finds its way into the gas-only chamber before the end of the riser because of a leak in the water jacket, it can seep into the cylinders when the engine is at rest and either seize the pistons with rust or create a "hydrolock" condition. This happens because water cannot be compressed in the cylinders, so the engine suffers massive and sometimes irreparable damage when you try to start it. Both result in the premature death of your engine.
